# Marjol Site Remediation Update

Number 93

July 7, 2009

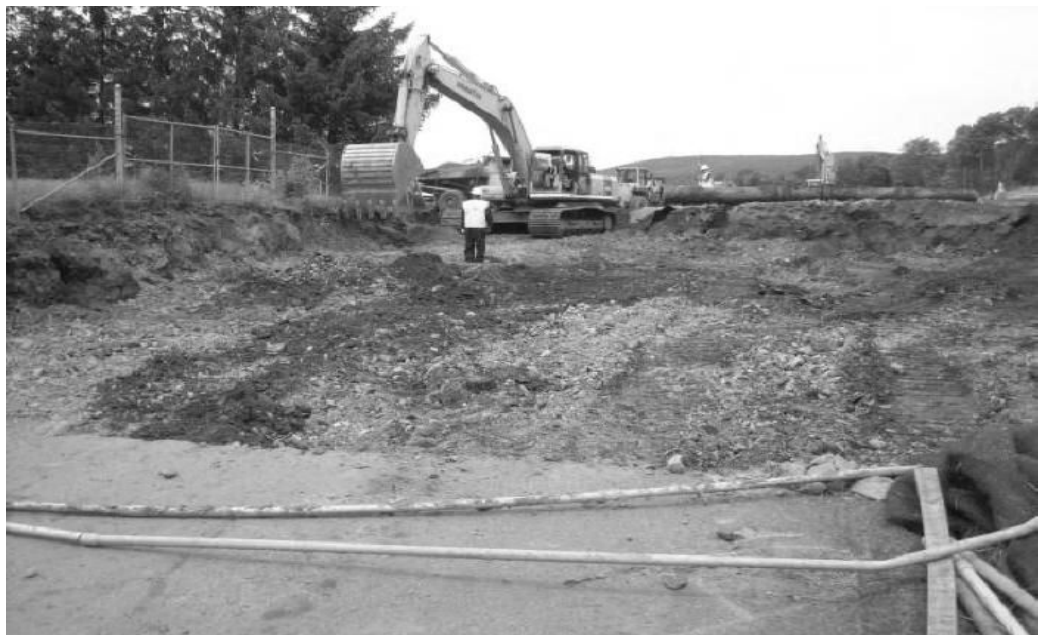
**Delaware Street Excavation (Inside the Perimeter Fence)**

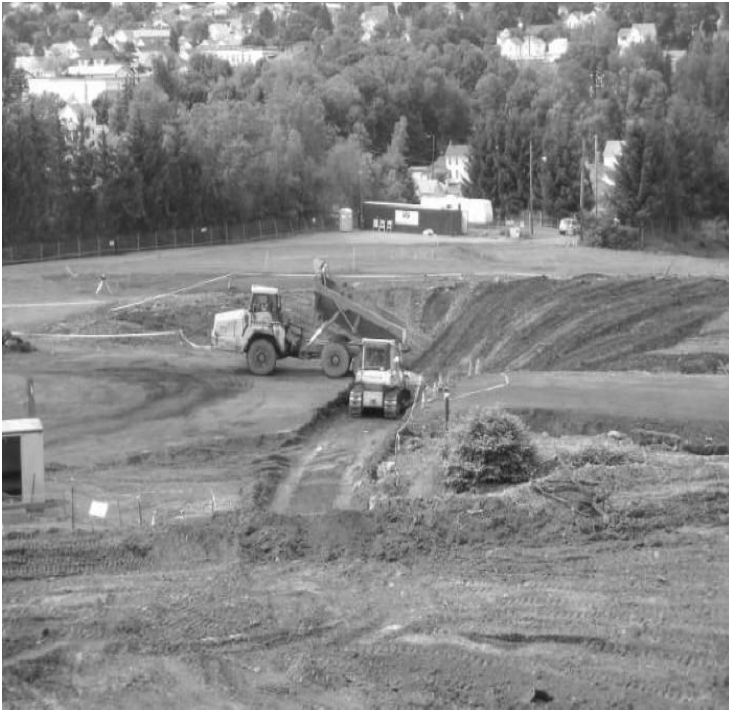
**Placement of Material in the Containment (Cap) Area**

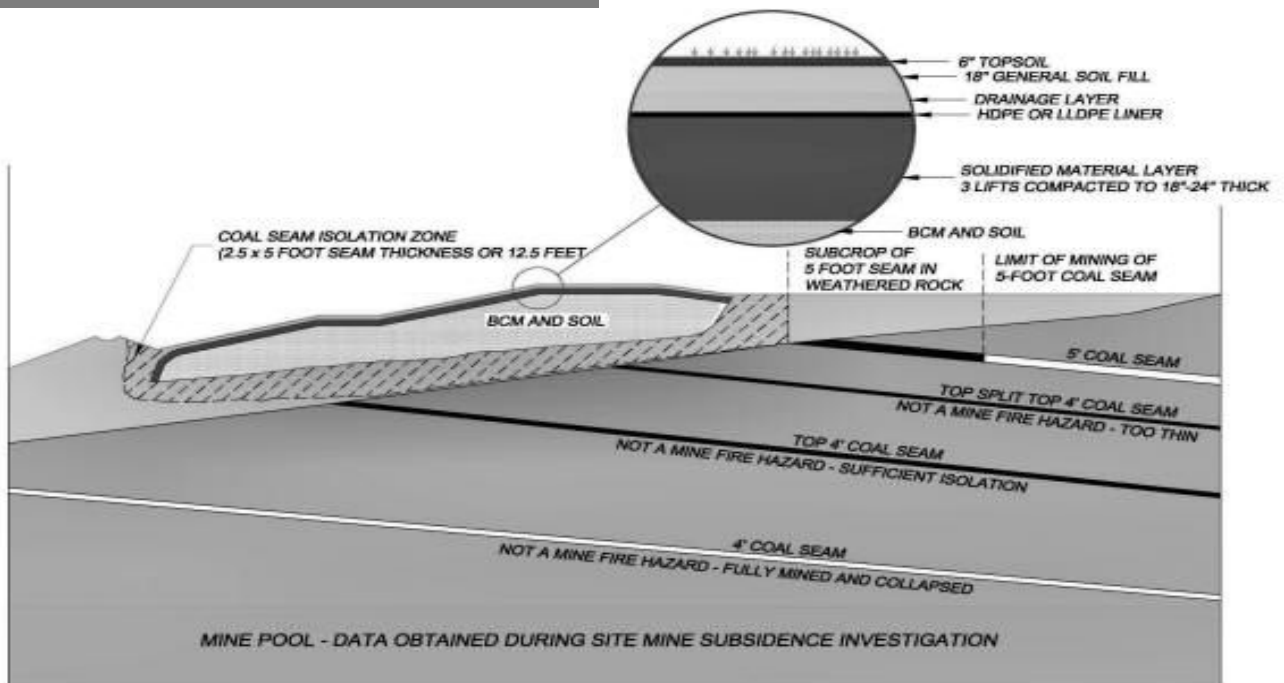
**GENERALIZED CROSS-SECTION WITH CONCEPTUAL REMEDY**

BCM = BATTERY CASING MATERIAL

Note: BCM = Battery Casing Material HDPE = high density polyethylene LLDPE= linear low density polyethylene

Once the solidified layer of the cap is complete, placement of the geotextile layers will begin. The drawing at the bottom of the page provides an overview of the layers of materials that will be placed over the contaminated material to create the cap.
